Vibrations Diagnosis and Condition Monitoring of Centrifugal Pumps at Al-Brega Oil Company

Ezedine G. Allaboudi ^{1*}, Khaled M. Ahmida ² ^{1,2} Department of Mechanical and Industrial Engineering, Faculty of Engineering, University of Tripoli, Libya

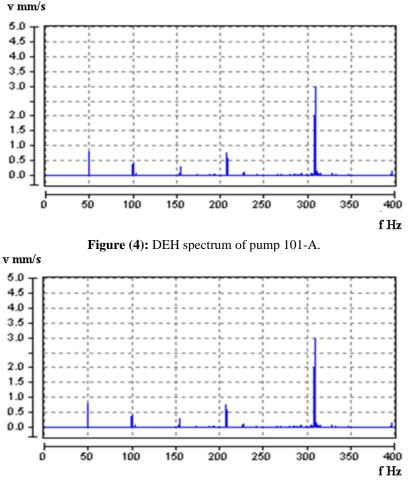
Figure (5): DEA spectrum of pump 101-A.

Compared to Table 9, the readings indicated damage to the bearing at the driving end of pump 101-A. Additionally, the readings from pump 206-A showed signs of friction caused by insufficient lubrication in the bearing. Therefore, the use of spectrum analysis is crucial for accurately identifying and detecting the problem. The comparison process with the spectrum standard was initiated, and the following figure 4 displays the spectrum for pump 101-A (DEH), while figure 5 shows the spectrum for pump 101-A (DEA).

Compared to the Mobius Institute standard shown in Figs. 6 and 7, the bearing issue is classified as bearing stage 5. This is due to its alignment with the peaks in the results spectrum, appearing as a decreasing wave that starts with the first peak (1x) and the 2x peak, disappearing at the 3x peak. The peak between 3x and 10 x indicates the harmonics, especially when sidebands are present, revealing visible wear on the bearing. Therefore, replacing the bearing is the recommended solution to address the issue. In addition, angular misalignment creates a bending moment on each shaft, leading to strong vibrations at 1X and some vibrations at 2X in the axial direction at both bearings. The results indicated that the angular misalignment is relatively small when compared to the ISO standard.

After completing the analysis, the recommendations were given to the maintenance team to carry out the necessary maintenance to address the identified issues. Once the maintenance team completed their tasks, diagnostic procedures for pump 206 were repeated, and the results obtained in Tables 10 and 11 showed that the pump problem was resolved.

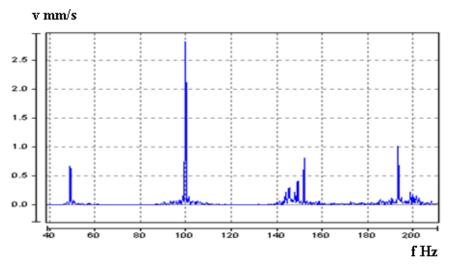
Figure (8): DEV motor spectrum of pump 206-A.

Similarly, the comparison process with the spectrum standard for pump 206-A was initiated, and figure 8 displays the spectrum for pump 206-A (DEV), while figure 9 shows the spectrum for pump 206-A (DEA).

In comparison to Figure 10, parallel misalignment creates both shear and bending moments at the coupled end of each shaft. This causes higher vibration levels at 1X and 2X in the radial directions (vertical and horizo7ntal) on the bearings on both sides of the coupling. The axial vibration levels at 1X and 2X are generally low in the case of pure parallel misalignment.
