Examination of the Mellitah Oil and Gas Complex's AISI 304 Stainless Steel Transmission Superheated Steam Pipeline: (Corrosion Failure)

Since petrochemical companies frequently employ 304 stainless steel pipes, this study was carried out on the same kind of pipe to examine the early failure of the high-pressure steam coil used in the fuel exhaust unit at Mellitah Industrial Complex. This failure manifested as vapor leaking through the spool's exterior surface fissures, which were evident. The hardness test, X-ray examination, microscopic inspection, visual inspection, and chemical analysis were the most crucial tests carried out to assess the metallurgical failure. The surface of the stainless-steel pipe had pitting erosion, as seen by the microscopic investigation photographs, the presence of this corrosion was confirmed after grinding and smoothing the surface of the sample. There is a good explanation why the ingot got damaged. Stress corrosion cracking (SCC) was discovered throughout the interior structure of the stainless-steel pipe, as shown by an X-ray inspection. The presence of the fractures was also visible in the microscopic photographs. By comparing the results of the

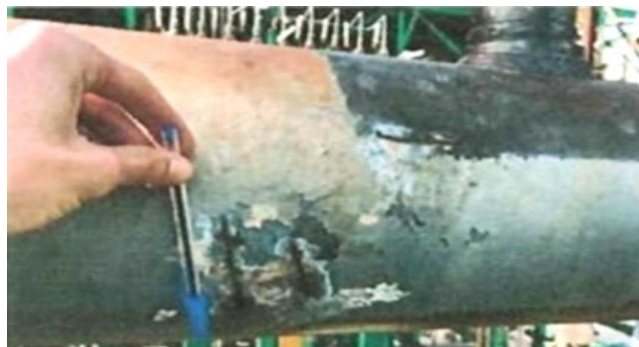
The sample is situated in the three zones of the thermal incinerator, as seen in Figure 2. This investigation was conducted in the third zone, which is related to steam superheating, while the other two zones are related to gas combustion. In order to do an investigation on damaged equipment, a small sample measuring 15.5 cm in length and 11 cm in width was cut.

Figure 2: The Shape of the Crack in the Spool Before Cutting.

The AISI 304 stainless steel pipeline's cracks on one side are depicted in Figure 2.2. There were two cracks visible: one was parallel to the cross section, and the other was a lit above in a line that was horizontal. It is evident that three of the fissures were oriented horizontally. However, after cutting and releasing the sample shown in Figures 9a, b and c, it was discovered that the inside surface was entirely coated in dark gray sediments. Furthermore, it is evident that there are longitudinal cracks with some peripheral branching. Additionally, it has been seen that there is a shallow depression visible and that the surface surrounding the fissures is strained.

The crack is below the side, not away from the injection valve, as shown in Figure 2.2. It is best defined as a sectional parallel crack with no welding spots and a region that looks to be in good condition. In Figures 9 a, b, and c and 10 a, b, and c, the cracks can be clearly noticed after cutting and grinding, their lengths being about a few centimeters.

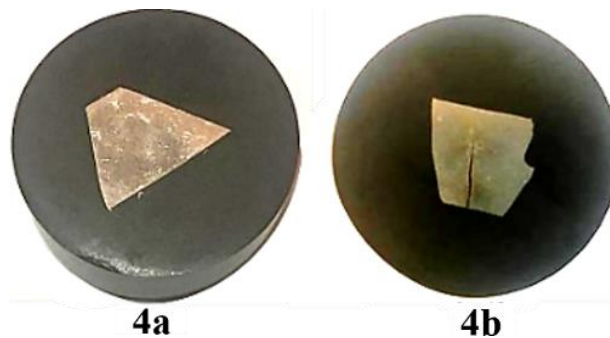
Figures 4 a and b show the final appearance of the two subjects, part of the crack area (a), and part of the intact area of the same sample (b).

Figures 4a and b: The Samples After Mounted.

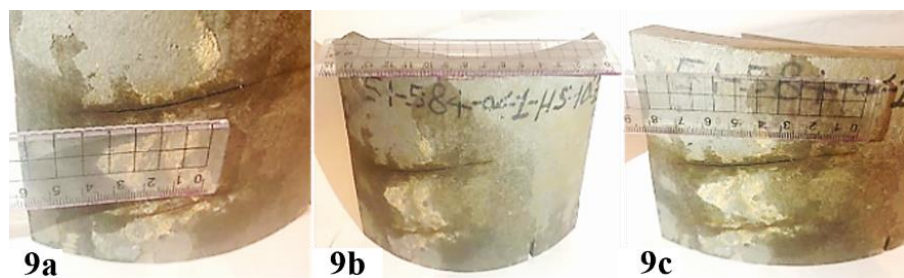
Figure 9a, b and c: The External Shape of the Specimen and the Approximate Length of the Notch after Cutting.

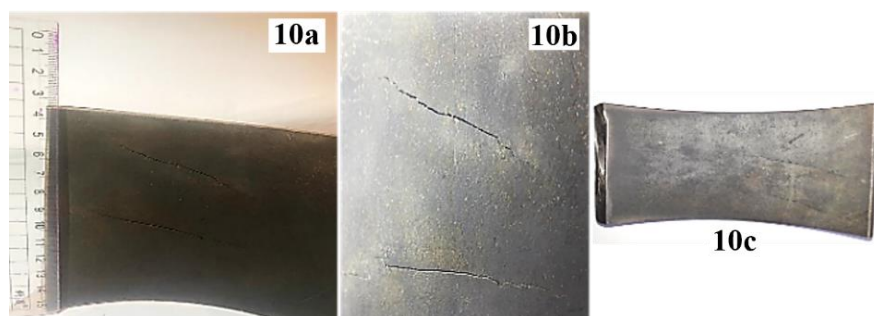
The inner surface's close-up photos at 1/100 magnification are displayed in Figures 10a, b and c, which also highlight the surface's dark gray tone and the magnitude of the fissure.

Figure 10a and b: Magnified Portion of the Crack from the Inner Surface and Figure 10c: The inner Surface of the Sample Covered with a Dark gray Sediment.

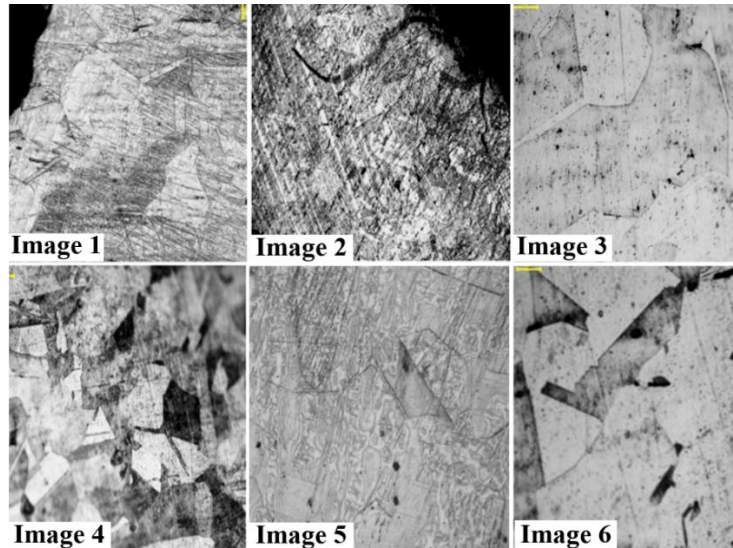
Figure 11: Microstructure of the Samples.

Six photos in Figure 11 shows examples of the structures that are exposed. Based on an analysis of the images, it can be concluded that crack bifurcations and their branches to the grain margins are present in images 1 and 2. However, pitting erosion is shown in images 3, 5, and 6.

Since high-pressure steam is the primary fluid in the AISI 304 Stainless Steel pipeline, this condition causes little spots to appear, as Figure 11 (images 3, 5, and somehow in image 6) clearly illustrates. These areas are known as pits, which lead to pitting failure. It is commonly recognized that this sort of corrosion can start other types of corrosion, such as uniform corrosion, stress corrosion, and fatigue corrosion. It can also go undetected and eventually penetrate the material. In actuality, greater temperatures throughout the production process can cause sensitization in austenitic stainless steels. The study specifically highlights the critical role that temperature-affected variations in oxide layer characteristics and their impact on pitting corrosion in AISI 304 stainless steel play [22].

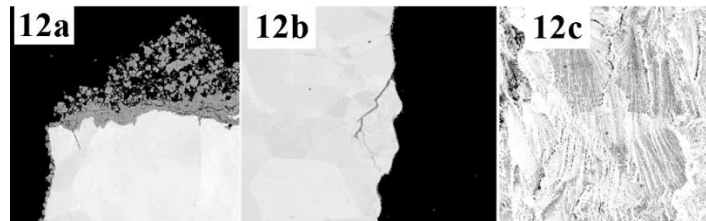
As can be seen in Figures 12a and b, comparing the reports of the Mellitah oil and gas complex, it was found that the failure happened due to the presence of tiny sub-cracks in the microscopic photographs of the same sample. On the surfaces of secondary fissures and cracks, there was additional sediment accumulation and covering. Also visible were the rivers on the fissures spanning the granules in Figure 12c.

Figure 12a, b and c: SEM Images of AISI 304 Stainless Steel Pipe Cracks Belongs to Mellitah Oil and Gas Complex Report.

It can be noted that the fracture has crossed the grain boundaries based on the most recent figures. It can also report some deformation in the vicinity of the crack. It was also observed that there isn't another type of bulging.

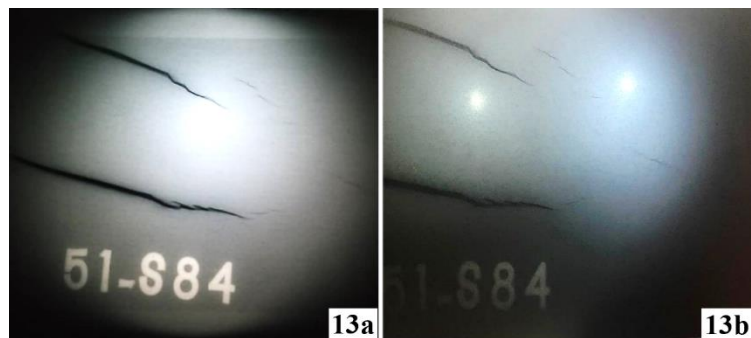
Figure 13: The X-Ray Radiographic Images.

Figures 13a and b show the X-ray images of the radiographic test, it can be noticed that there are some microcracks.
