Vibrations Diagnosis and Condition Monitoring of Centrifugal Pumps at Al-Brega Oil Company

Ezedine G. Allaboudi ^{1*}, Khaled M. Ahmida ² ^{1,2} Department of Mechanical and Industrial Engineering, Faculty of Engineering, University of Tripoli, Libya

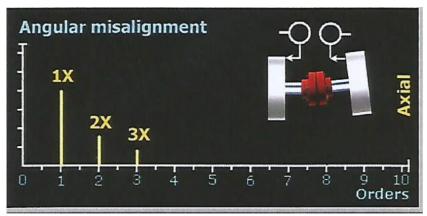
Figure (7): Mobius institute standard (Angular misalignment).

Compared to the Mobius Institute standard shown in Figs. 6 and 7, the bearing issue is classified as bearing stage 5. This is due to its alignment with the peaks in the results spectrum, appearing as a decreasing wave that starts with the first peak (1x) and the 2x peak, disappearing at the 3x peak. The peak between 3x and 10 x indicates the harmonics, especially when sidebands are present, revealing visible wear on the bearing. Therefore, replacing the bearing is the recommended solution to address the issue. In addition, angular misalignment creates a bending moment on each shaft, leading to strong vibrations at 1X and some vibrations at 2X in the axial direction at both bearings. The results indicated that the angular misalignment is relatively small when compared to the ISO standard.

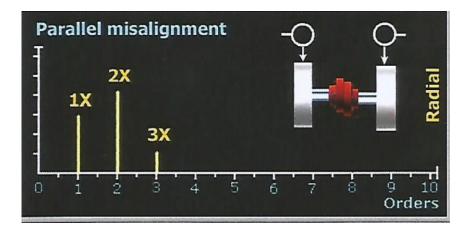
Figure (10): Mobius institute standard (Parallel misalignment).

In comparison to Figure 10, parallel misalignment creates both shear and bending moments at the coupled end of each shaft. This causes higher vibration levels at 1X and 2X in the radial directions (vertical and horizo7ntal) on the bearings on both sides of the coupling. The axial vibration levels at 1X and 2X are generally low in the case of pure parallel misalignment.

After completing the analysis, the recommendations were given to the maintenance team to carry out the necessary maintenance to address the identified issues. Once the maintenance team completed their tasks, diagnostic procedures for pump 206 were repeated, and the results obtained in Tables 10 and 11 showed that the pump problem was resolved.
