Examination of the Mellitah Oil and Gas Complex's AISI 304 Stainless Steel Transmission Superheated Steam Pipeline: (Corrosion Failure)

Since petrochemical companies frequently employ 304 stainless steel pipes, this study was carried out on the same kind of pipe to examine the early failure of the high-pressure steam coil used in the fuel exhaust unit at Mellitah Industrial Complex. This failure manifested as vapor leaking through the spool's exterior surface fissures, which were evident. The hardness test, X-ray examination, microscopic inspection, visual inspection, and chemical analysis were the most crucial tests carried out to assess the metallurgical failure. The surface of the stainless-steel pipe had pitting erosion, as seen by the microscopic investigation photographs, the presence of this corrosion was confirmed after grinding and smoothing the surface of the sample. There is a good explanation why the ingot got damaged. Stress corrosion cracking (SCC) was discovered throughout the interior structure of the stainless-steel pipe, as shown by an X-ray inspection. The presence of the fractures was also visible in the microscopic photographs. By comparing the results of the

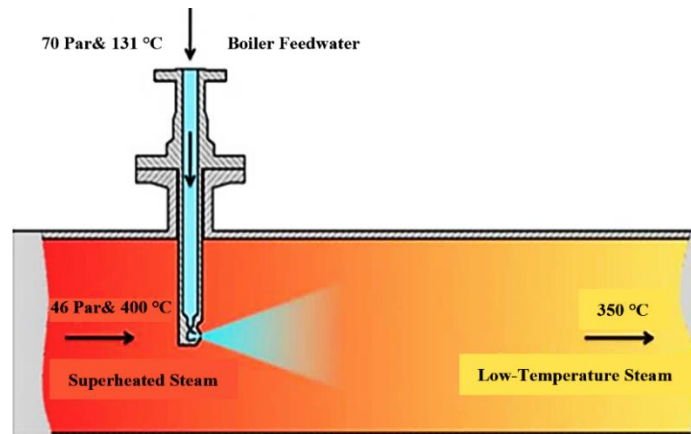
Figure 1: Mechanism of the Spool Working.

A 12.7-mm-thick sample of 300-class stainless steel of type H 304 was taken from a spool used in the superheated steam transmission lines in the fuel exhaust equipment. The spool enters the superheater steam horizontally at a pressure of 46 bar and 400 C, with a flow rate of 25801 kg/h. The superheated steam enters the spool vertically in the first quarter, under 70 bar and 131 °C, and exits the spool with superheated steam that is 50 degrees lower than the entry temperature. Figure 1 shows the mechanism of spool working. As illustrated in Figure 2, deep longitudinal cracks appear in this spool, which is coded 584-HL001-51, after the superheated water vapor and boiler feed water spray have mixed for approximately 10 cm.
